The collapse of the reject water treatment and its revival at Bekkelaget WWTP

March 31st 2022

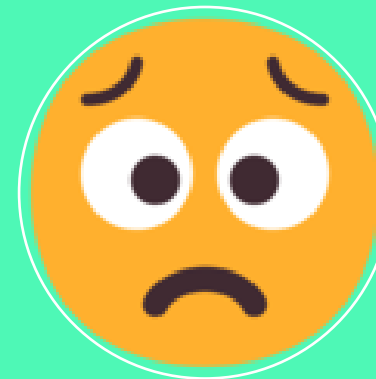
2) Introduced a new
digester with the
expansion of the plant

AOB

Anammox

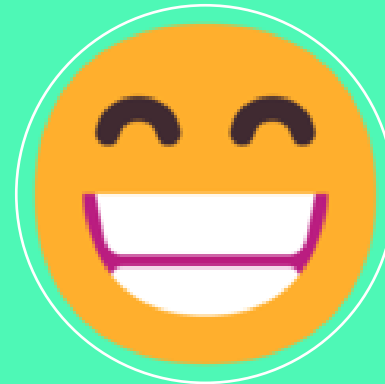
AOB

Anammox

4) AOBs recovered more quickly when the pH decreased, producing poisonous levels of NO_2^- for the Anammox bacteria
